WEST GEORGIA HOME
INSPECTION & RENOVATION
SERVICES, LLC

Property located at 6505 Rico Road,
Chattahoochee Hills Georgia 30268

Robert N. Olsavsky Phone 770-823-1282
19 October 2020

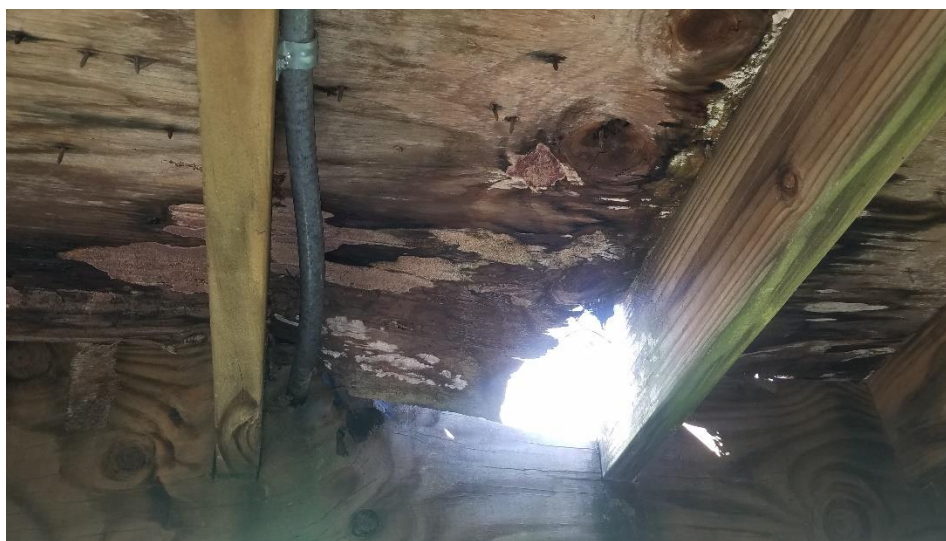
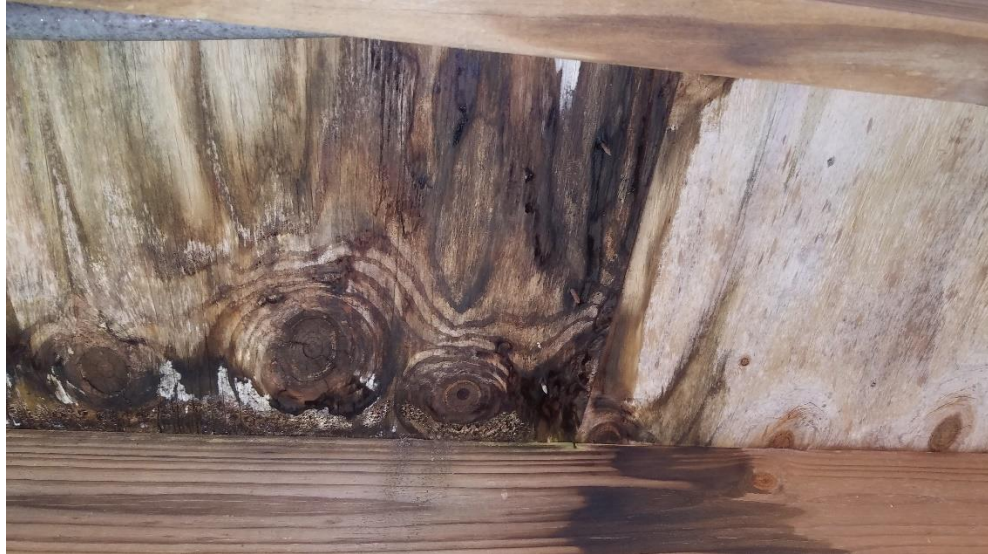
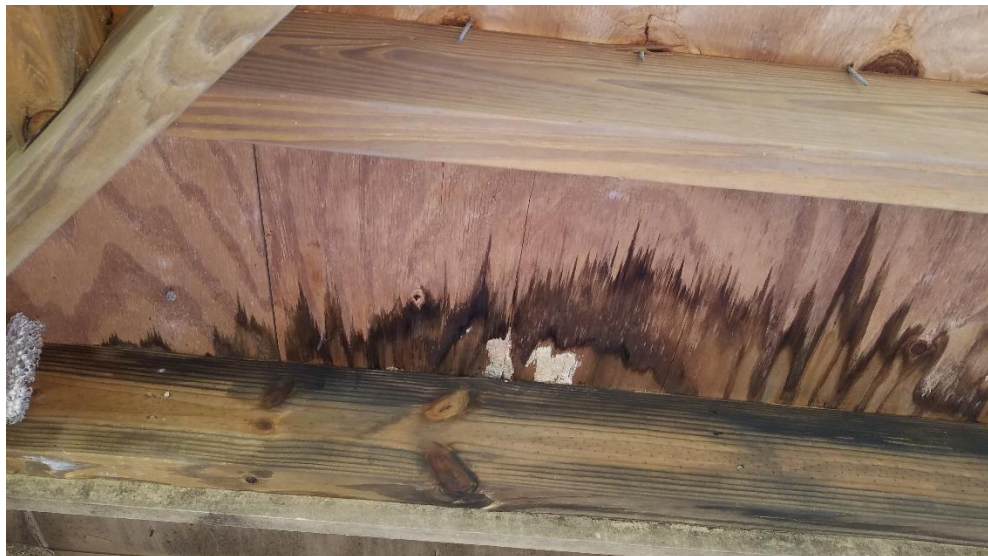
The roof on the main structure of the building is of the three tab shingle type and appears to be in fair condition. No evidence of a leak was observed on the ceiling of the second floor of this building. The surrounding porch roof on the second floor is considerable deteriorated. Large holes are rotted in the plywood roof decking and the shingles are missing of some of these areas. Rain water coming off of the main roof is running through these open areas in the roof deck and down on to the wood porch and wood side of the building, causing further water damaged. The rain water then drips through the porch and on to the ground at the left side of the building making the water management problem even worse. Upon inspection of the attic, some of the rafters for the main section of the building are rotted out at their base where they connect with the side porch roof, compromising their strength integrity.

Recommendations: The roof on the side porch is deteriorated and unsafe to walk under. A roofing company will need to strip off the remaining shingles of the side porch roof and remove all of the current wood decking. A new roof deck will then need to be constructed and new shingles installed.

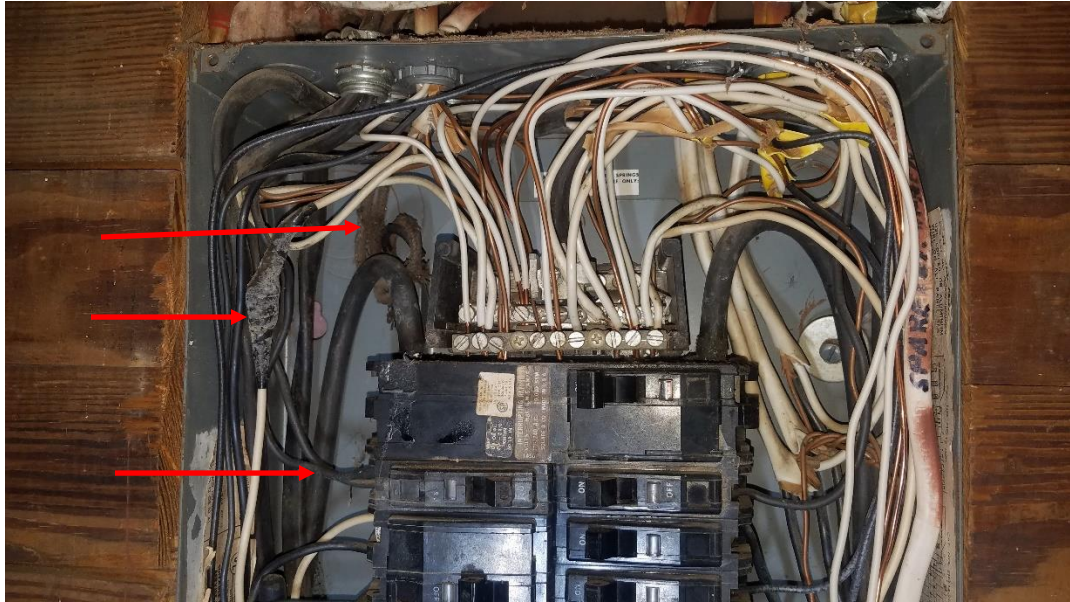
Electrical systems The electrical service panel in this building is located on the first floor in the front right hand corner. A 100 amp circuit breaker type panel was observed. The panel cover was removed for a closer inspection. It was apparent from looking inside of this panel that several generations of wiring have been used in the building, including the original knob and tube type wiring. Several modifications have been made to this panel over the years, none of them in an electrical code approved manner. Knob and tube wiring was observed inside of the panel, as well as spliced together wires, dead heads (wires with wire nuts on the ends), and double taps (two wires on the same breaker). The breakers also do not appear to be the correct size (amperage) for the intended loads for this building. It is not known because it could not be observed, but it is likely that the knob and tube

type wiring extends into the walls of this building and to at least some of the outlets and fixtures, causing a fire hazard.

A test of all outlets in the building was performed. A variety of electrical issues were observed including ungrounded outlets, reversed polarity of outlet wiring, GFI outlets that do not trip and reset, and dead outlets. The second floor wiring of this building appears to be more recent and is in much better condition than the rest of the building wiring. No electrical issues were observed on the second floor of this building other than the old style two prong outlets.

Knob and tube wiring.

Wire splices.

Double taps.

Recommendations: An electrician needs to replace the main breaker panel in this building, as well as all sub standard wiring, which may not be possible without removing some of the wall material. The size of the panel needs to be determined ahead of time as to the future intended use of this building. For example, if a kitchen is to be utilized, and much bigger panel would need to be installed than if a kitchen is not to be utilized. An electrician also needs to convert all 2 prong type outlets to 3 prong type outlets, or remove them entirely, to correct this safety issue. GFI outlets need to be installed in the proper locations and wired correctly so that they will trip and reset as intended. The main power line coming from the electrical pole may also need to be increased in size.

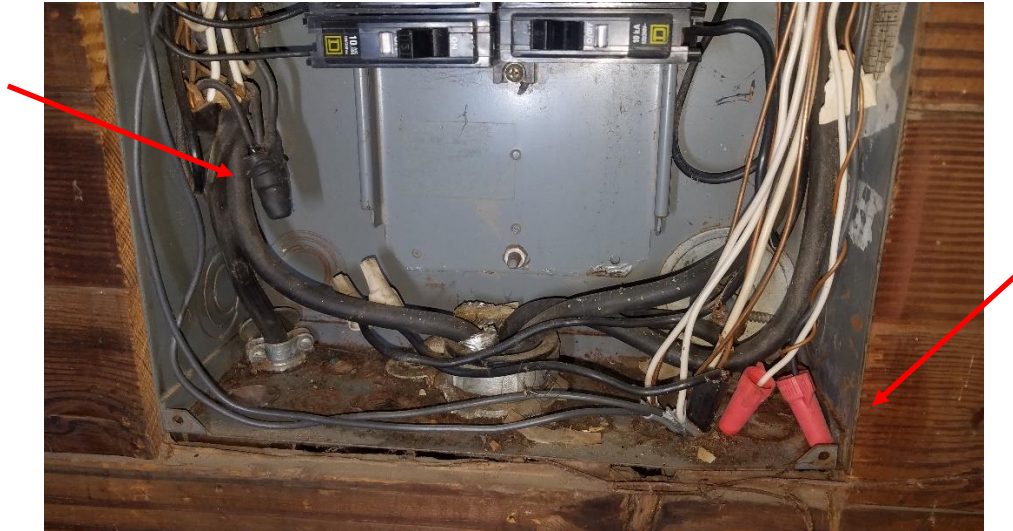
Dead heads.

Wire splices.

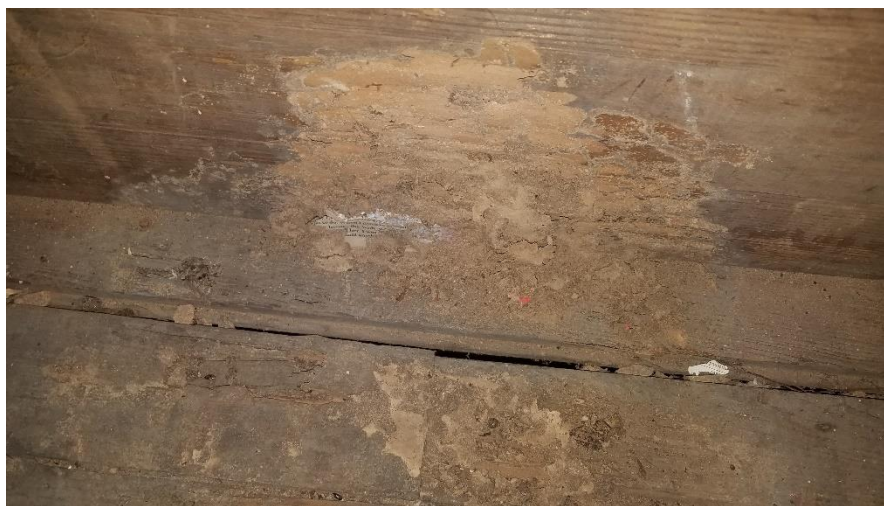
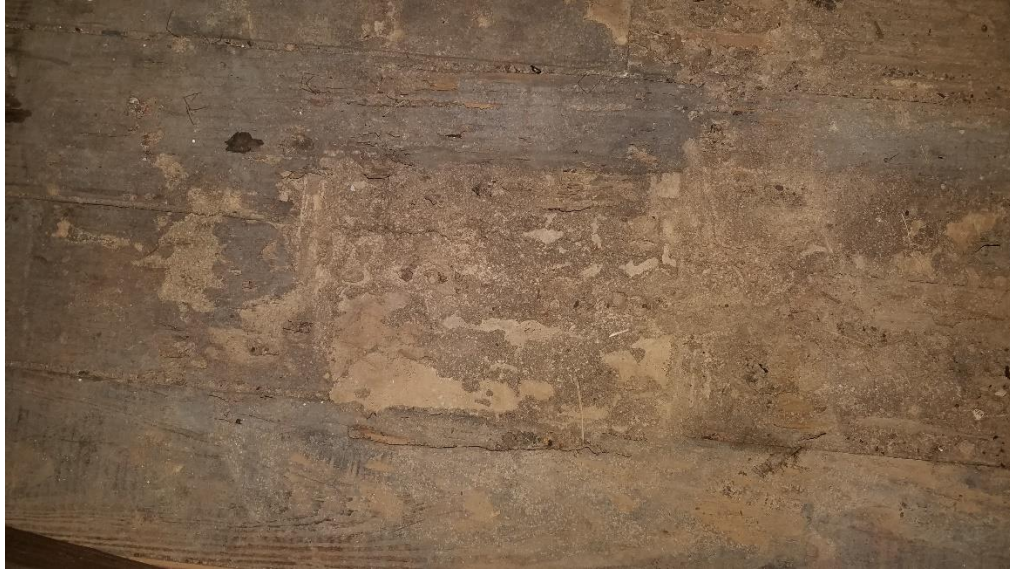
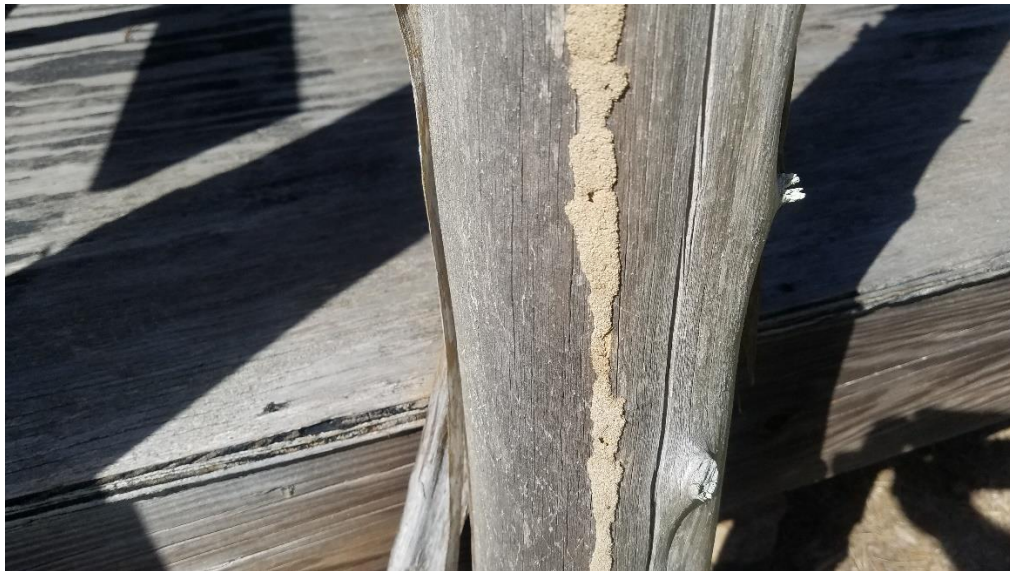
The main support structure of this building is compromised for all of the reasons detailed earlier in this report. An inspection of the crawl space showed that there are floor joists sitting directly on top of the ground under the building, providing an easy path for termite intrusion, which has occurred. Termite tunnels are visible on the exterior of the building. There is no evidence of any past termite treatment ever being performed on this building. As a result, termite activity has eaten away at the support beams and walls of this building, evidence of which can be observed inside of the building. Since most termite damage is not visible, the sagging of the floors and walls can be attributed to this problem.

Recommendations: A full termite treatment for this building will need to be done to prevent a further damage. A construction company that specializes in termite damage repair will then need to be retained to remove and replace all of the termite damaged wood to stabilize this building.

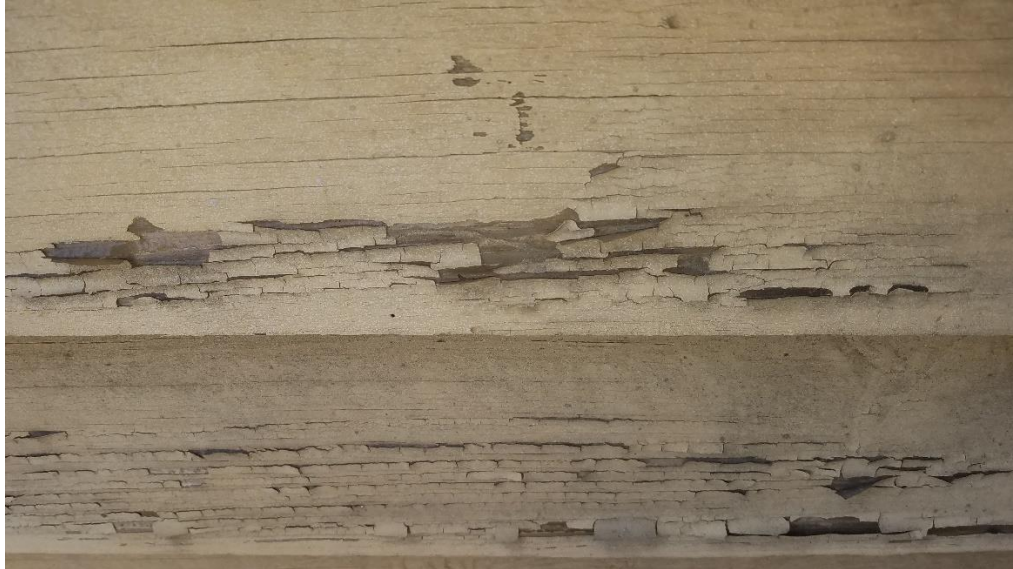
The outside surface of this building has been painted with a lead based paint some time ago. Old peeling lead paint is visible all around the outside surface of this building. The paint is dry and peeling to the touch such that painting over it would not be possible as it would still flake off. The existing lead paint needs to be scraped, sanded, or sand blasted off before a new coat of paint can be applied. Many of the side boards are in poor condition and will need to be replaced during this process. Lead paint is considered a hazardous material by the EPA, so a certified lead paint removal company will need to be retained. All paint debris will need to be captured, triple bagged, and taken to a hazardous waste dump for disposal.

A painting contractor certified to perform lead based paint work will need to be retained to remove all of the peeling lead based paint, and then repaint the building in a weather proof outdoor grade paint to prevent future weather damage.

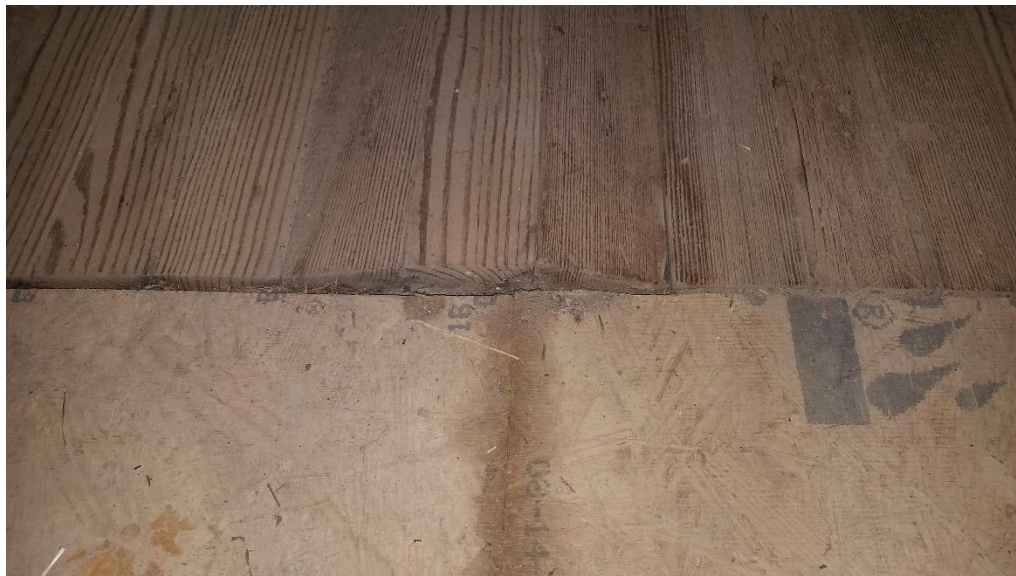
The wood floor on the first level of this building is buckled near the back of the room from water damage under the floor boards. After correcting the water problem, these floor boards will need to be secured back in place to prevent further buckling and potentially a safety hazard.

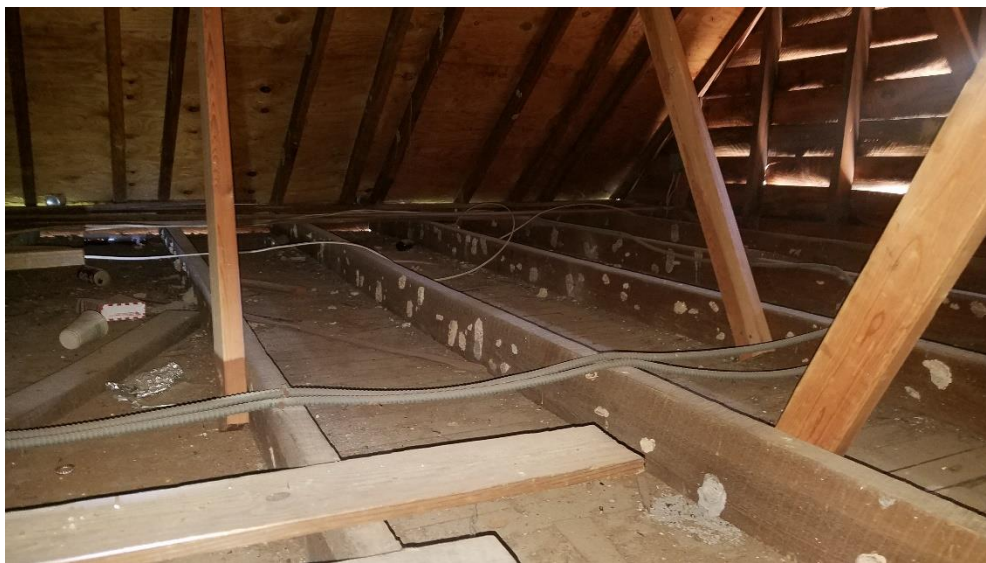
This building has no central heating and air conditioning service, so there is no duct work or freon lines. There is also no insulation in the walls or ceilings of this building, making it impractical to try to heat and cool in its present state. There are two propane gas wall heaters in this building, neither of which worked, and would be unsafe to use with the building in its current state anyway.

If this building is intended to be used for public activities, some sort of environmental controls will need to be installed or the building will be uninhabitable during the summer and winter months.
